# ACE HOME INSPECTION, Inc.

**ACE Inspection No.:** R5000-17

**Property Address:** 123 Main Street  
Anytown, NJ

**Inspection Date:** February 30, 2017- 10:00 AM to 1:00 PM

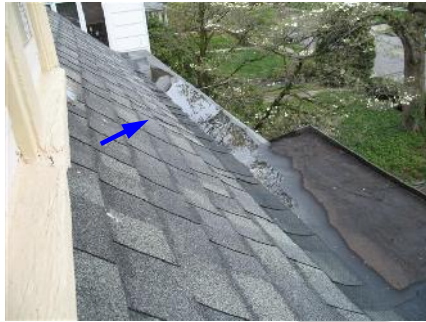
- 1) The roof underside ventilation is deficient and likely voids manufacturer's roof warranty. The roof may experience a shortened service life as a result. Cathedral ventilation is needed;
- 2) The roof surface material is lifting at the skylights, can allow water penetration and need flashing repairs;
- 3) Shingles are sliding from position due to the lack of proper nailing at front and rear skylight- re-nailing is needed, and the entire roof needs to be gone over for other sliding shingles;
- 4) See flashing issues below which also need repairs, in next section of report.
- 5) See Roof rainwater management section of report for issues.

[Slipping shingles, gutters holding water](#)

**Issues with roof need repair. Indicators of sub-standard installation are evident. Contact qualified roofing contractors for repair estimates. Specialists are needed for the built in gutters. Defects and concerns are enumerated below and are not limited.**

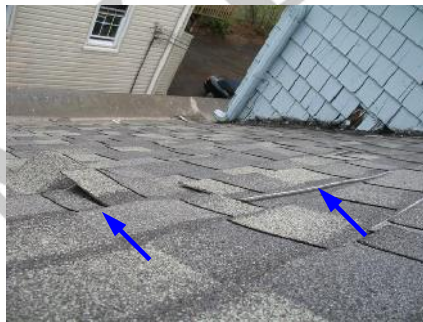
[Lifting shingles/slipping shingles](#)

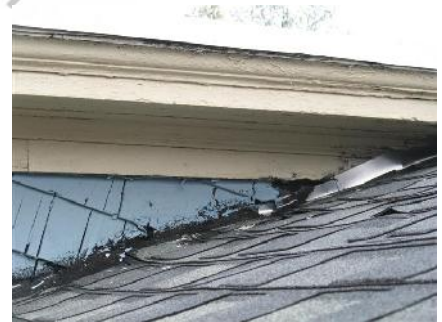
[Poor quality flashing installation](#)

There is evidence of past and likely continuing water seepage/penetration as a result of this installation. All areas where ceilings and walls are damaged are suspect.

Obtain assurance this roof has a building permit and approval.

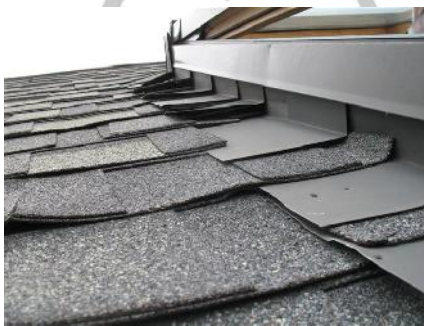
[Lifting skylight flashing](#)

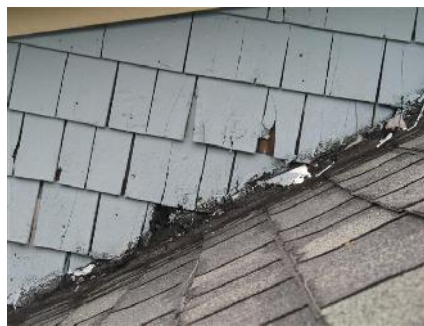
[Item a](#)

- a) Inadequate flashing details at shed dormers' wood shingle counter flashings insufficient- shed dormers' wood shingles need removal and replacement to function as proper counter flashing;

**Roof flashings are generally improperly installed, deficient, can leak and need repairs by a qualified roofer. Obtain estimates for repair.**

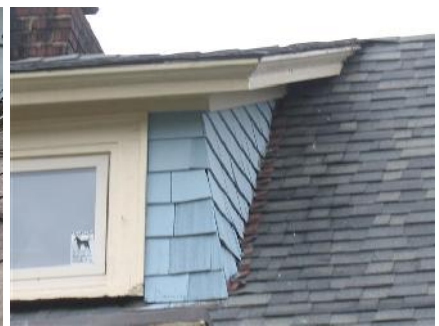
[Item e](#)

- d) No kick-out flashings are installed where required and can allow siding leakage;
- e) Front shed dormer flashings are re-used and not properly installed as are out of sync with the roof shingles. Leakage can occur as now exposed to the elements. Old ferrous metal flashings will quickly deteriorate. Removal and replacement with modern new materials is needed.
